APPENDIX D
Geotechnical Hazard Reports

Orange Bluff Evaluation Report

Subject: “Revised” Geologic Hazards Evaluation Report, Orange Bluff Site, East 28th Street and Orange Avenue, City of Signal Hill, California (Assessor Parcel Nos. 7212-008-049, 7212-008-051, 7212-010-010, 7212-010-019, and 7212-010-020).

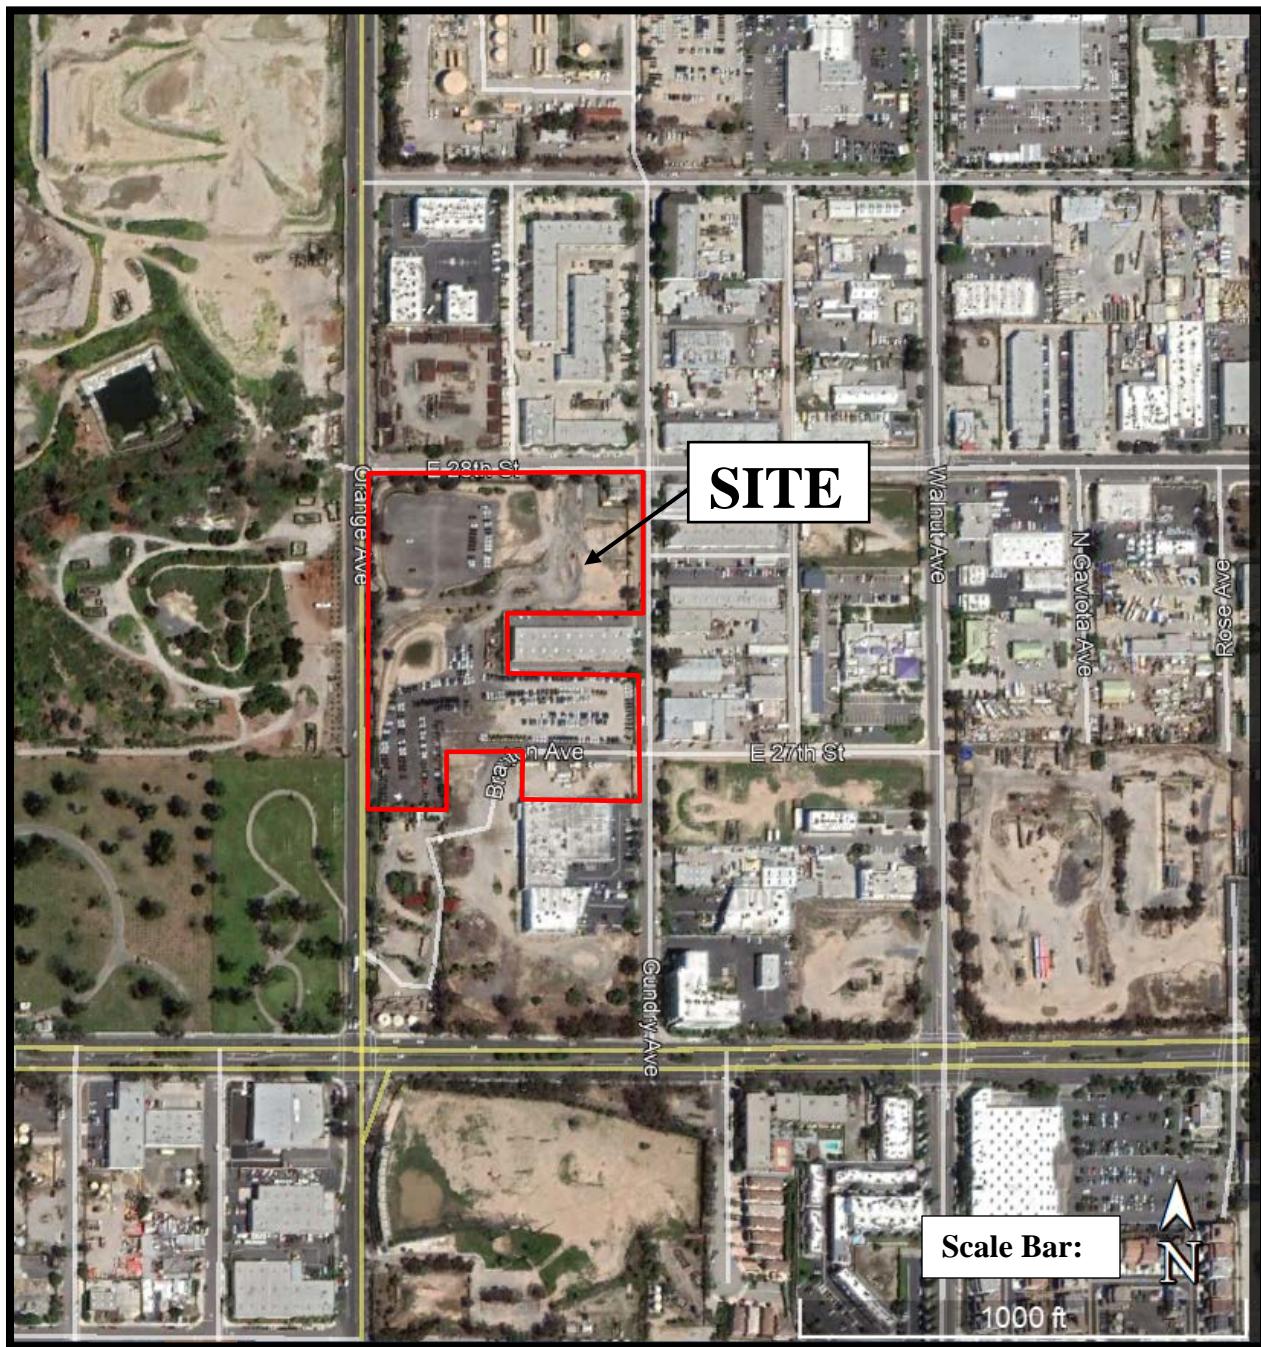
**SITE LOCATION MAP
FIGURE 1**

Source: 2021 Google Earth©

Topographically, the site is generally situated on the top of an uplifted hill that forms the northwest extension (nose) of Signal Hill. The site is relatively flat to gently sloping to the northwest and north. Ground surface elevations within the site, based on Google Earth imagery, currently range from approximately 150 feet above mean sea level at the southeastern margin of the site to approximately 113 feet above mean sea level at the northern margin of the site.

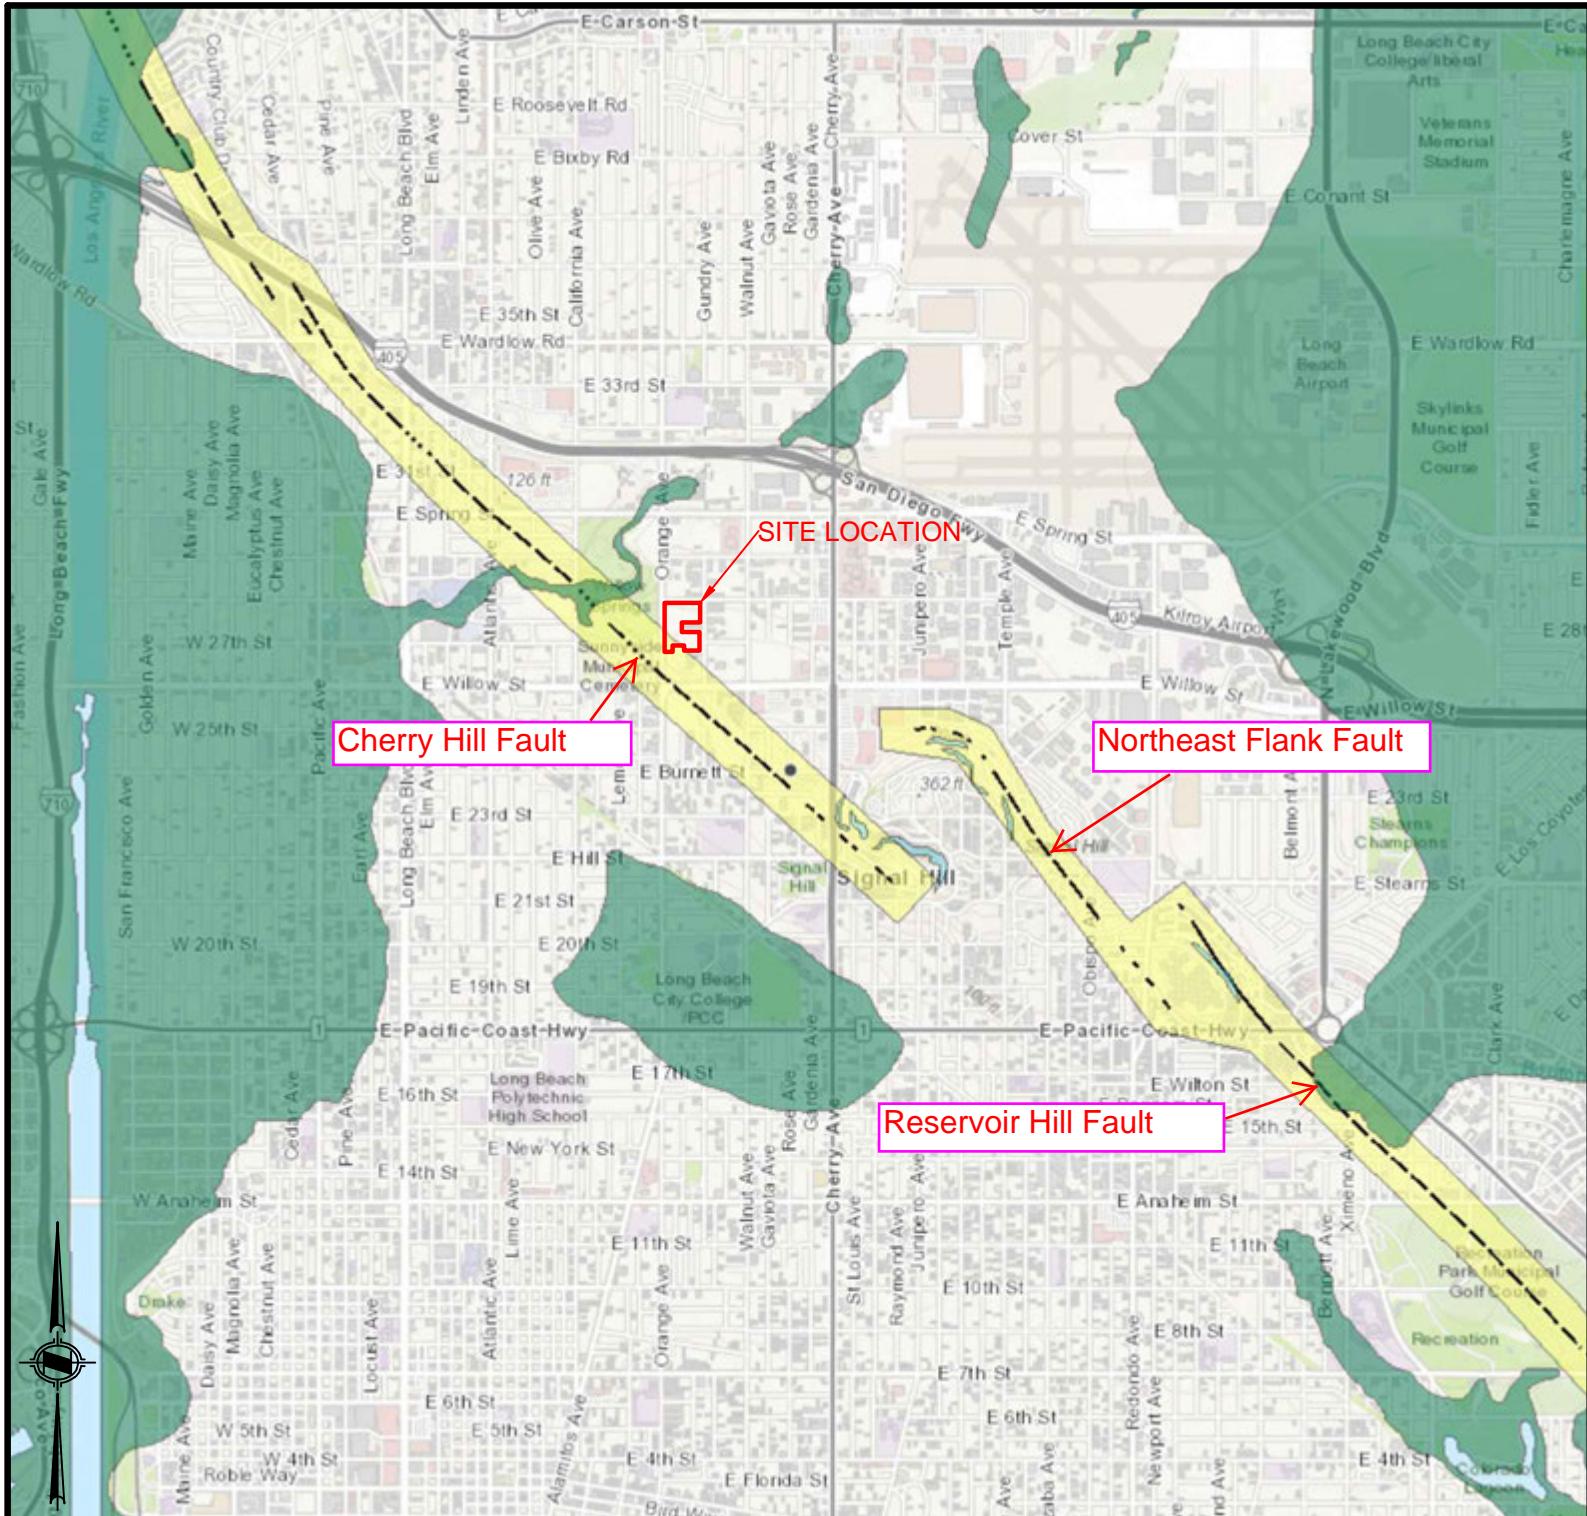
SCALE : 1" = 3000'

The far southwestern portion of the site is located within the boundary of an Earthquake Fault Zone (EFZ) associated with the Cherry Hill fault (see Seismic Hazard Map, Plate 1). The Cherry Hill fault, as discussed in Section 3.1, is a major segment of the NIFZ. Based on our referenced fault study for the site (Albus, 2021), we found no evidence of faulting in our offsite fault trench. Thereby, demonstrating that there is no evidence of faulting that could project into the southwest corner of the site within the limits of EFZ as well as a distance of 50 feet beyond the southwest corner of the site, based on the regional trend of the Cherry Hill fault. In addition, results of previous fault studies in the area have also shown that there is no evidence of faulting projecting toward the site. Furthermore, some of the studies conducted west, south, and southeast of the immediate vicinity of the site have exposed the Cherry Hill fault in trenches. As a result, the Cherry Hill fault is moderately to well defined in the vicinity of the site and at its closest approach is approximately 250 feet southwest of the site.

The southwestern portion of the site is located within the boundary of an Earthquake Fault Zone associated with the Cherry Hill fault (See Seismic Hazards Map, Plate 1). Earthquake Fault Zones are delineated by the State of California to define areas where fault rupture hazard investigations are required prior to building structures for human occupancy. No structure for human occupancy is permitted over the trace of an “active” fault. An “active” fault, as defined by the state, is a fault that has had surface displacement during Holocene time (last 11,700 years).

The project site is relatively flat to gently sloping and is not located immediately adjacent steep terrain. As such, geologic hazards associated with landsliding are not anticipated at the site. The site is not located within an area identified by the California Geological Survey (CGS) as having potential for seismic slope instability (See Seismic Hazards Map, Plate 1).

Groundwater is anticipated to be more than 50 feet below the ground surface and the site is also underlain by relatively dense materials of the Lakewood and San Pedro Formations. As such, liquefaction is unlikely to occur at the site. The site is not located within a mapped California Geological Survey liquefaction hazard zone (See Seismic Hazards Map, Plate 1).

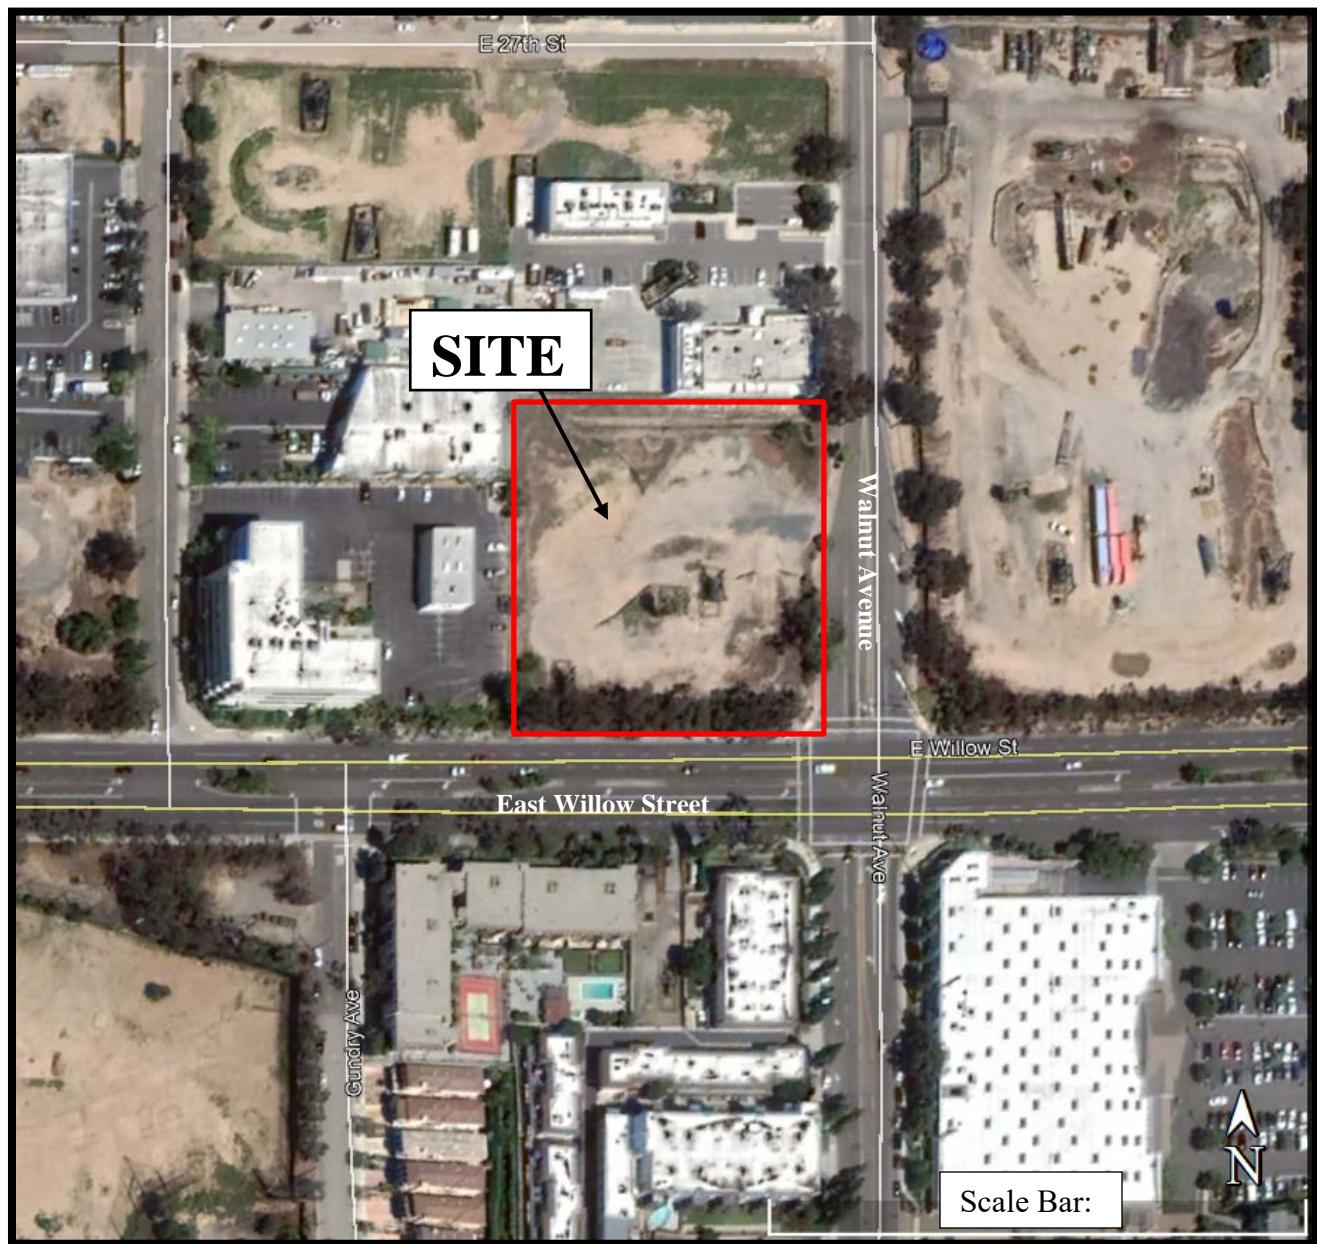
**SITE LOCATION MAP
FIGURE 1**

Source: 2021 Google Earth

Topographically, the site is largely situated on the top of an uplifted hill that forms the northwest extension (nose) of Signal Hill. The site is relatively flat to very gently sloping to the north. Ground surface elevations within the site, based on Google Earth imagery, currently range from approximately 162 feet above mean sea level at the southeastern corner of the site to approximately 155 feet above mean sea level at the northern margin of the site. Site drainage is generally by sheet flow to the north.

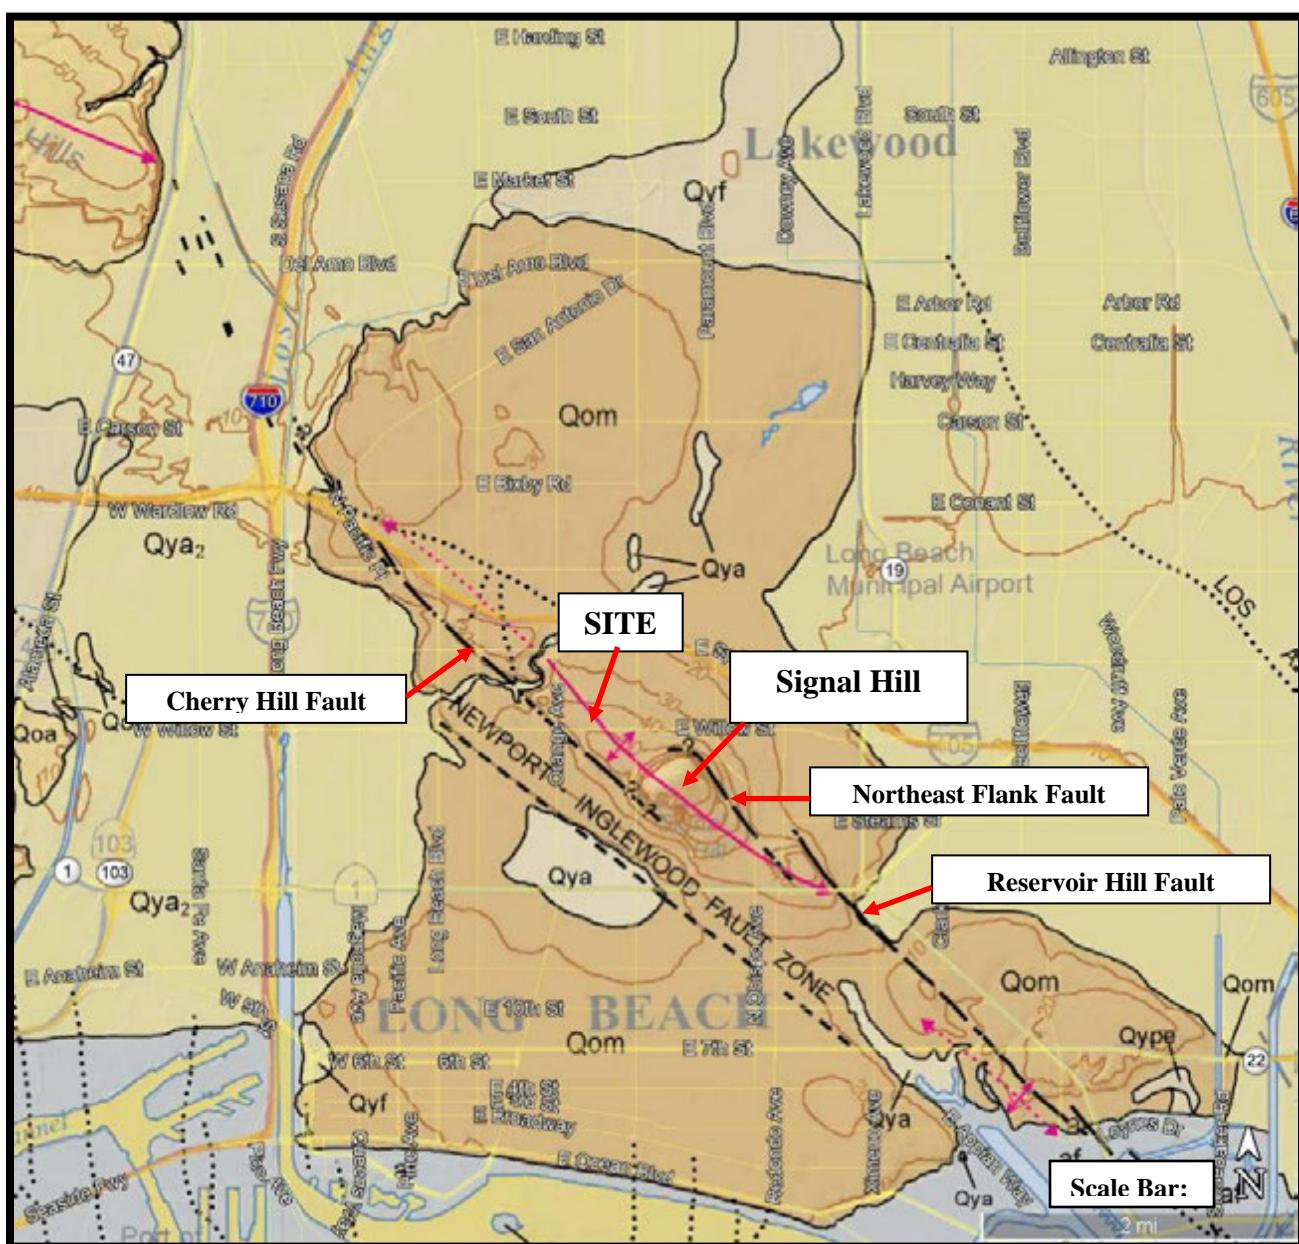
REGIONAL GEOLOGIC MAP
FIGURE 2

af	Artificial fill (only selected larger fills shown)
Qya	Young alluvium, undivided
Qya₂	Young alluvium, Unit 2
Qyf	Young alluvial fan deposits, undivided
Qye	Young paralic estuarine deposits
Qoa	Old alluvium, undivided
Qom	Old shallow marine deposits on wave-cut surface

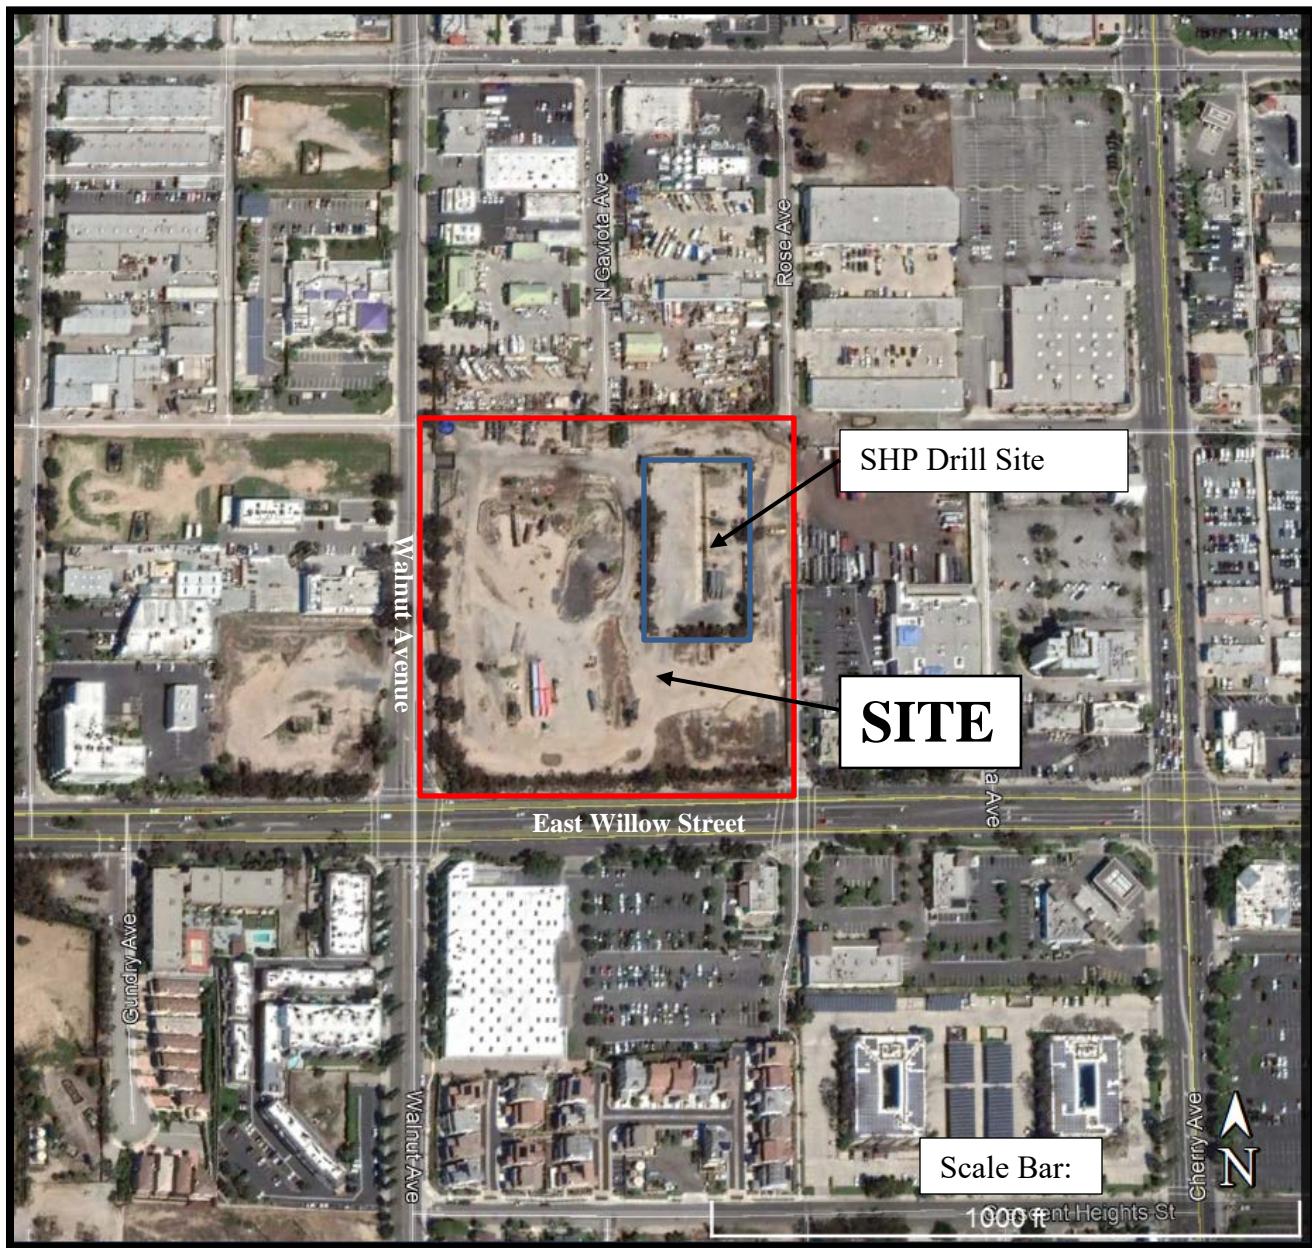
**SITE LOCATION MAP
FIGURE 1**

Source: 2021 Google Earth

Topographically, the site is largely situated on the top of an uplifted hill that forms the northwest extension (nose) of Signal Hill. The site is relatively flat to very gently sloping to the north. Ground surface elevations within the site, based on Google Earth imagery, currently range from approximately 162 feet above mean sea level at the southwest corner of the site to approximately 138 feet above mean sea level at the far northeastern corner of the site. Site drainage is generally by sheet flow to the north.

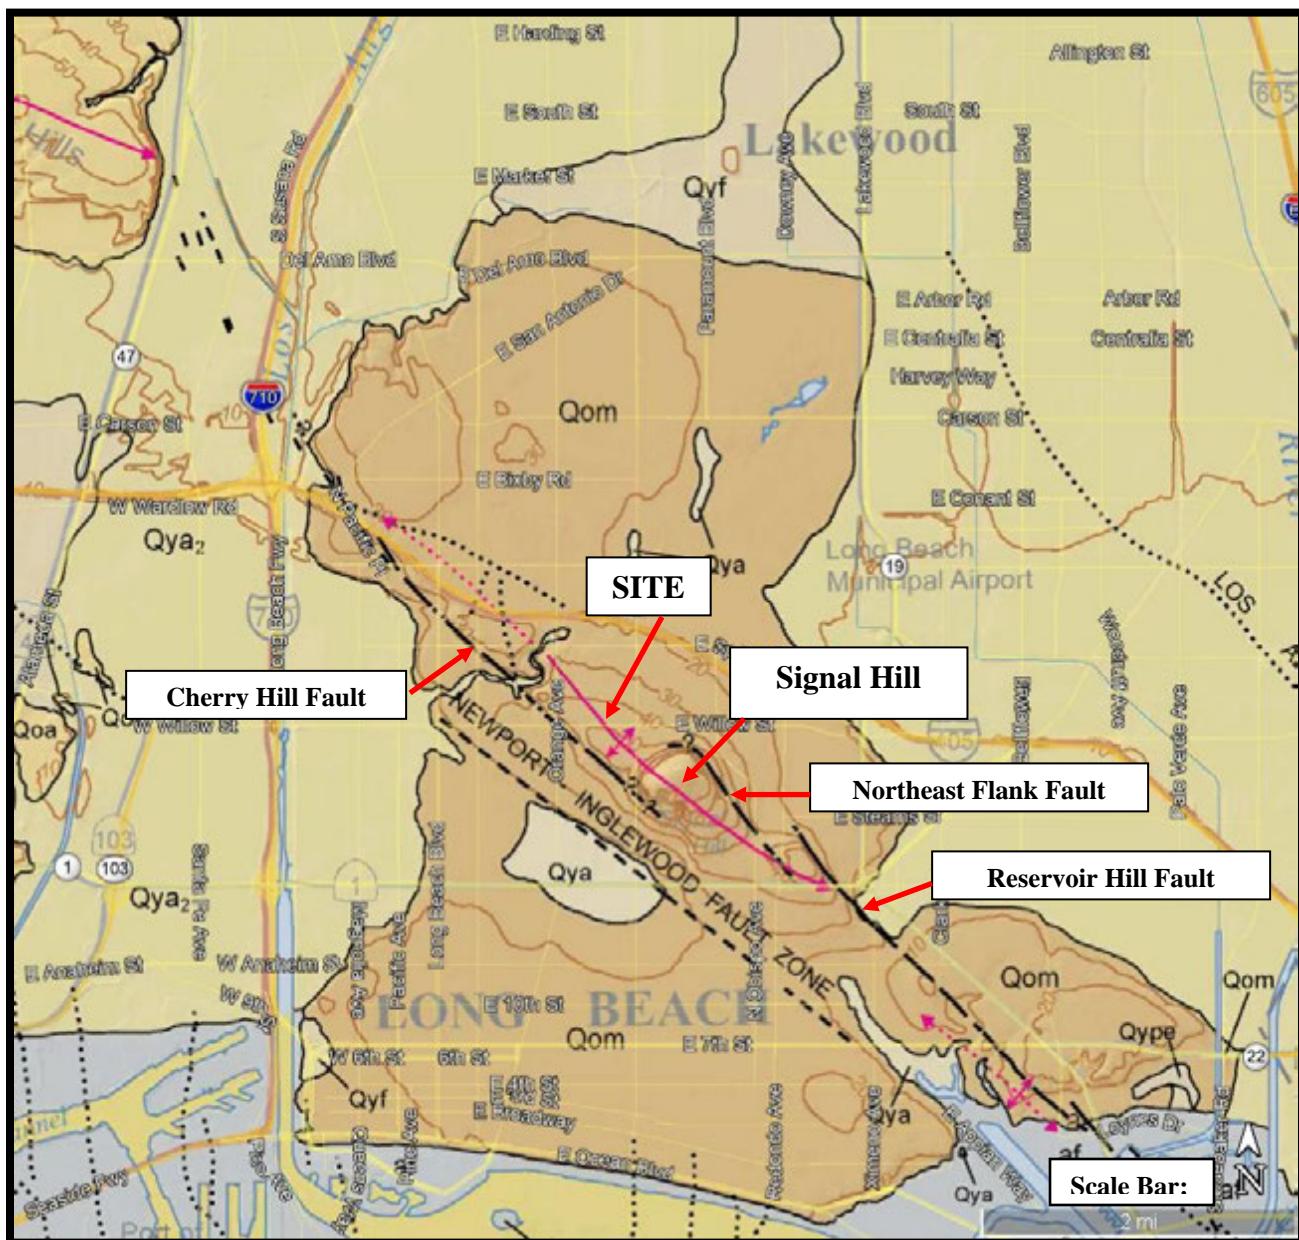
REGIONAL GEOLOGIC MAP FIGURE 2

af	Artificial fill (only selected larger fills shown)
Qya	Young alluvium, undivided
Qya ₂	Young alluvium, Unit 2
Qyt	Young alluvial fan deposits, undivided
Qype	Young paralic estuarine deposits
Qoa	Old alluvium, undivided
Qom	Old shallow marine deposits on wave-cut surface

Structurally, Signal Hill rises about 300 feet above the surrounding terrain and forms a complex northwest-trending anticlinal dome structure overprinted on a larger preexisting anticlinal structure. As shown on the Regional Geologic Map, Figure 2, Signal Hill is bounded by two major northwest-trending step-over fault segments of the NIFZ; the Cherry Hill fault to the southwest and the Northeast Flank fault to the northeast. These surface faults are believed to be interconnected at depth to form one near vertical “master fault” (Barrows, 1974). In essence, this postulated vertical master fault, or fault zone flowers upward to form the near surface fault structures. The resulting compressive stresses formed between the step-over fault segments and flowering structures are believed to be at least partially responsible for the substantial fracturing and uplifting of Signal Hill (St. Peters and Whitney, 1992).

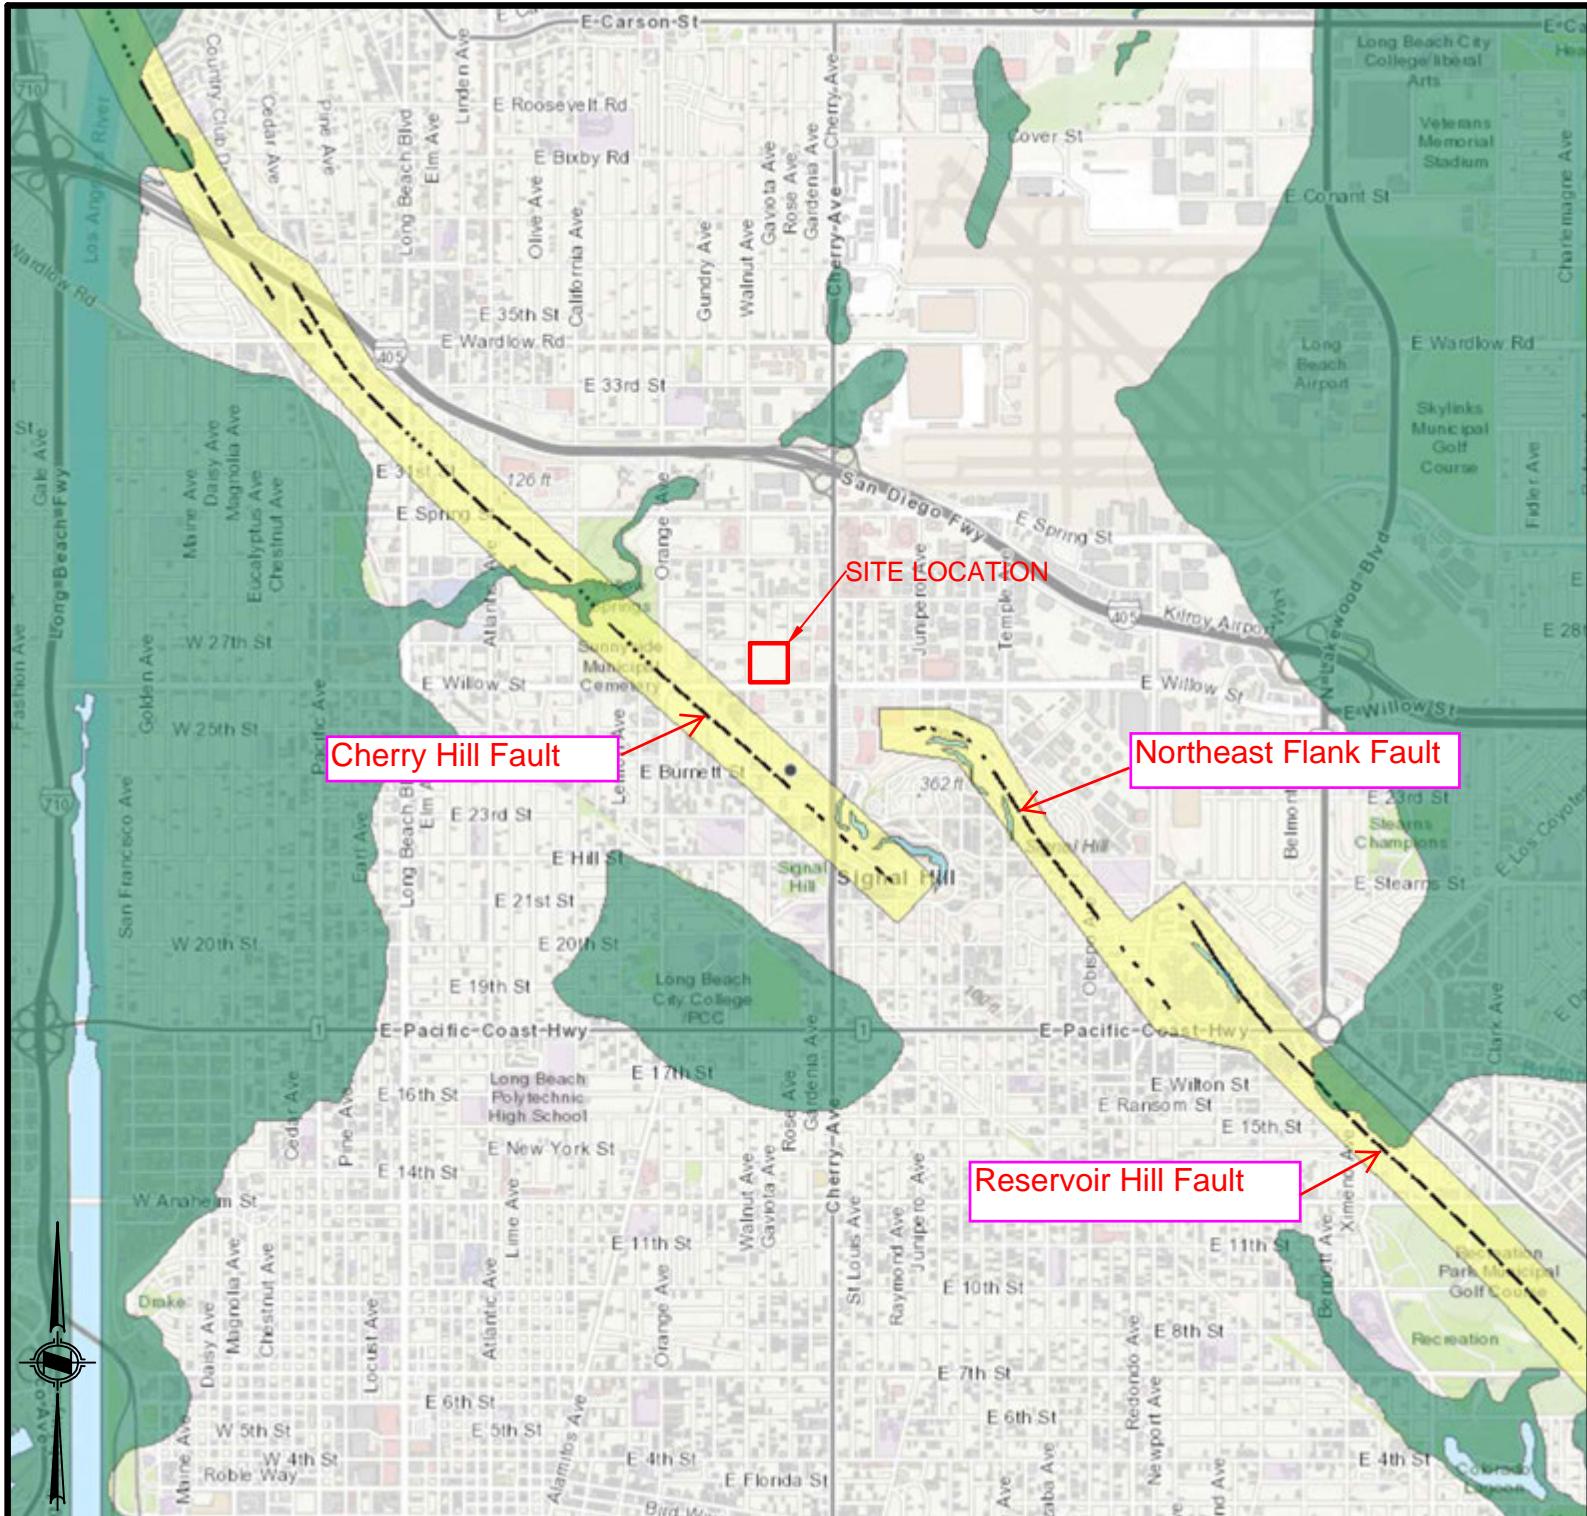
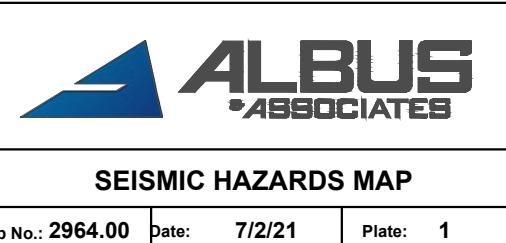
Active Fault Traces

Faults considered to have been active during Holocene time and have potential for surface rupture: Solid Line in Black or Red where accurately located; Long Dash in Black or Solid Line in Purple where approximately located; Short dash in black or solid line in orange where inferred; Dotted line in black or solid line in rose where concealed; Query (?) indicates additional uncertainty. Evidence of historic offset indicated by year of earthquake-associated event or C for displacement caused by fault creep.

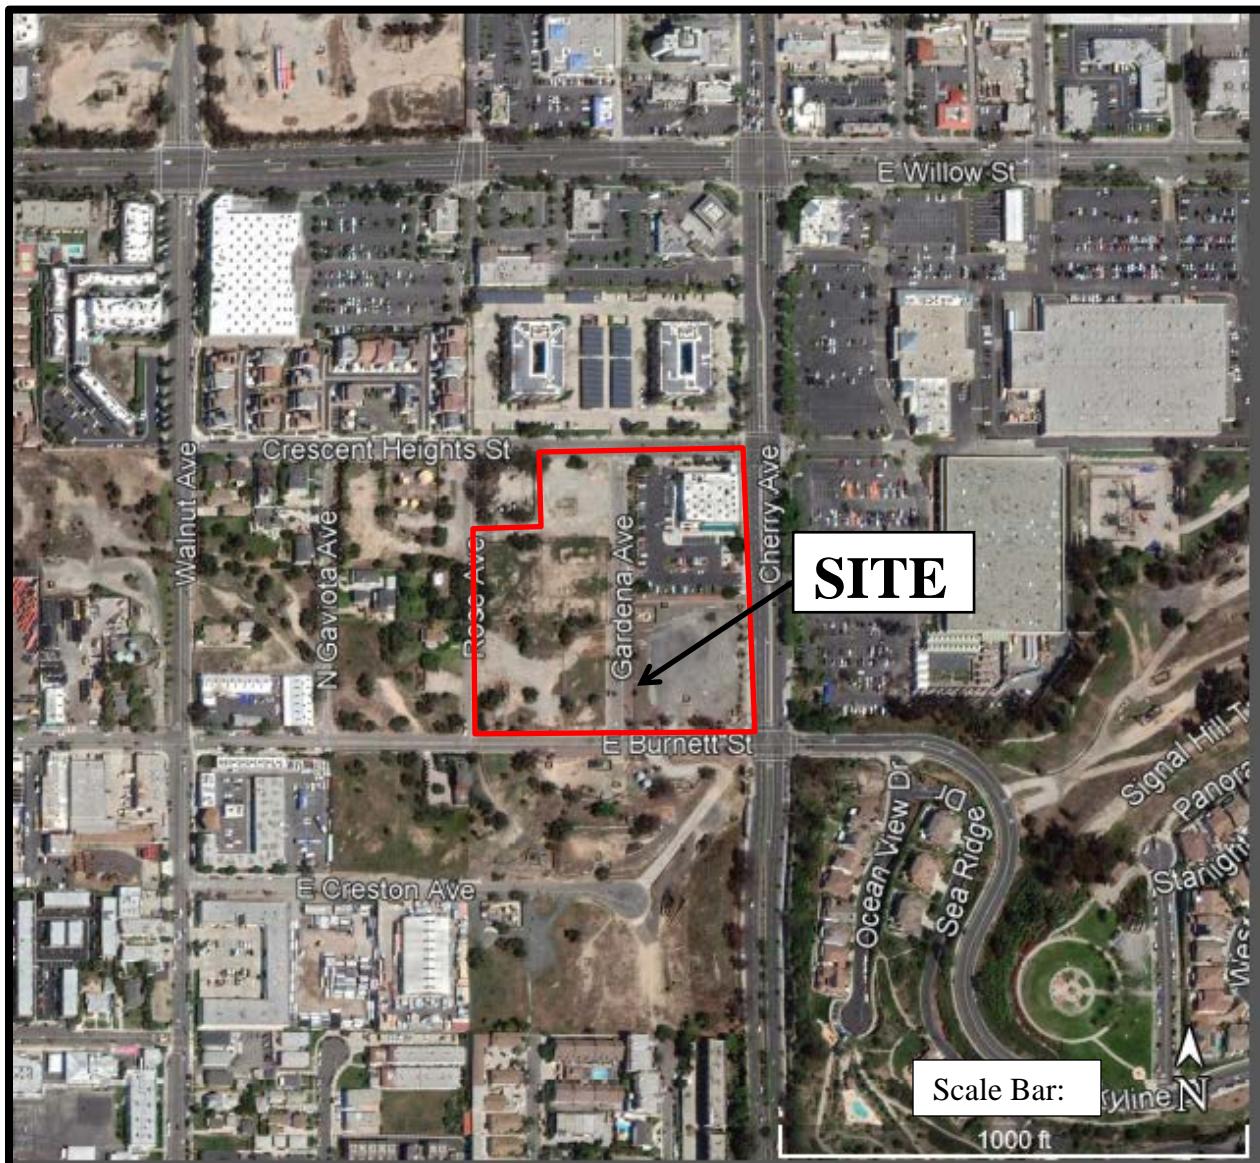
**SITE LOCATION MAP
FIGURE 1**

Source: 2021 Google Earth ©

Topographically, the site is generally situated on the top of an uplifted hill that forms the northwest extension (nose) of Signal Hill. The site is relatively flat to gently sloping to the northeast. Ground surface elevations within the site vary from approximately 187 feet above mean sea level in the southwestern corner of the site to approximately 165 feet above mean sea level in the northeastern portion of the site.

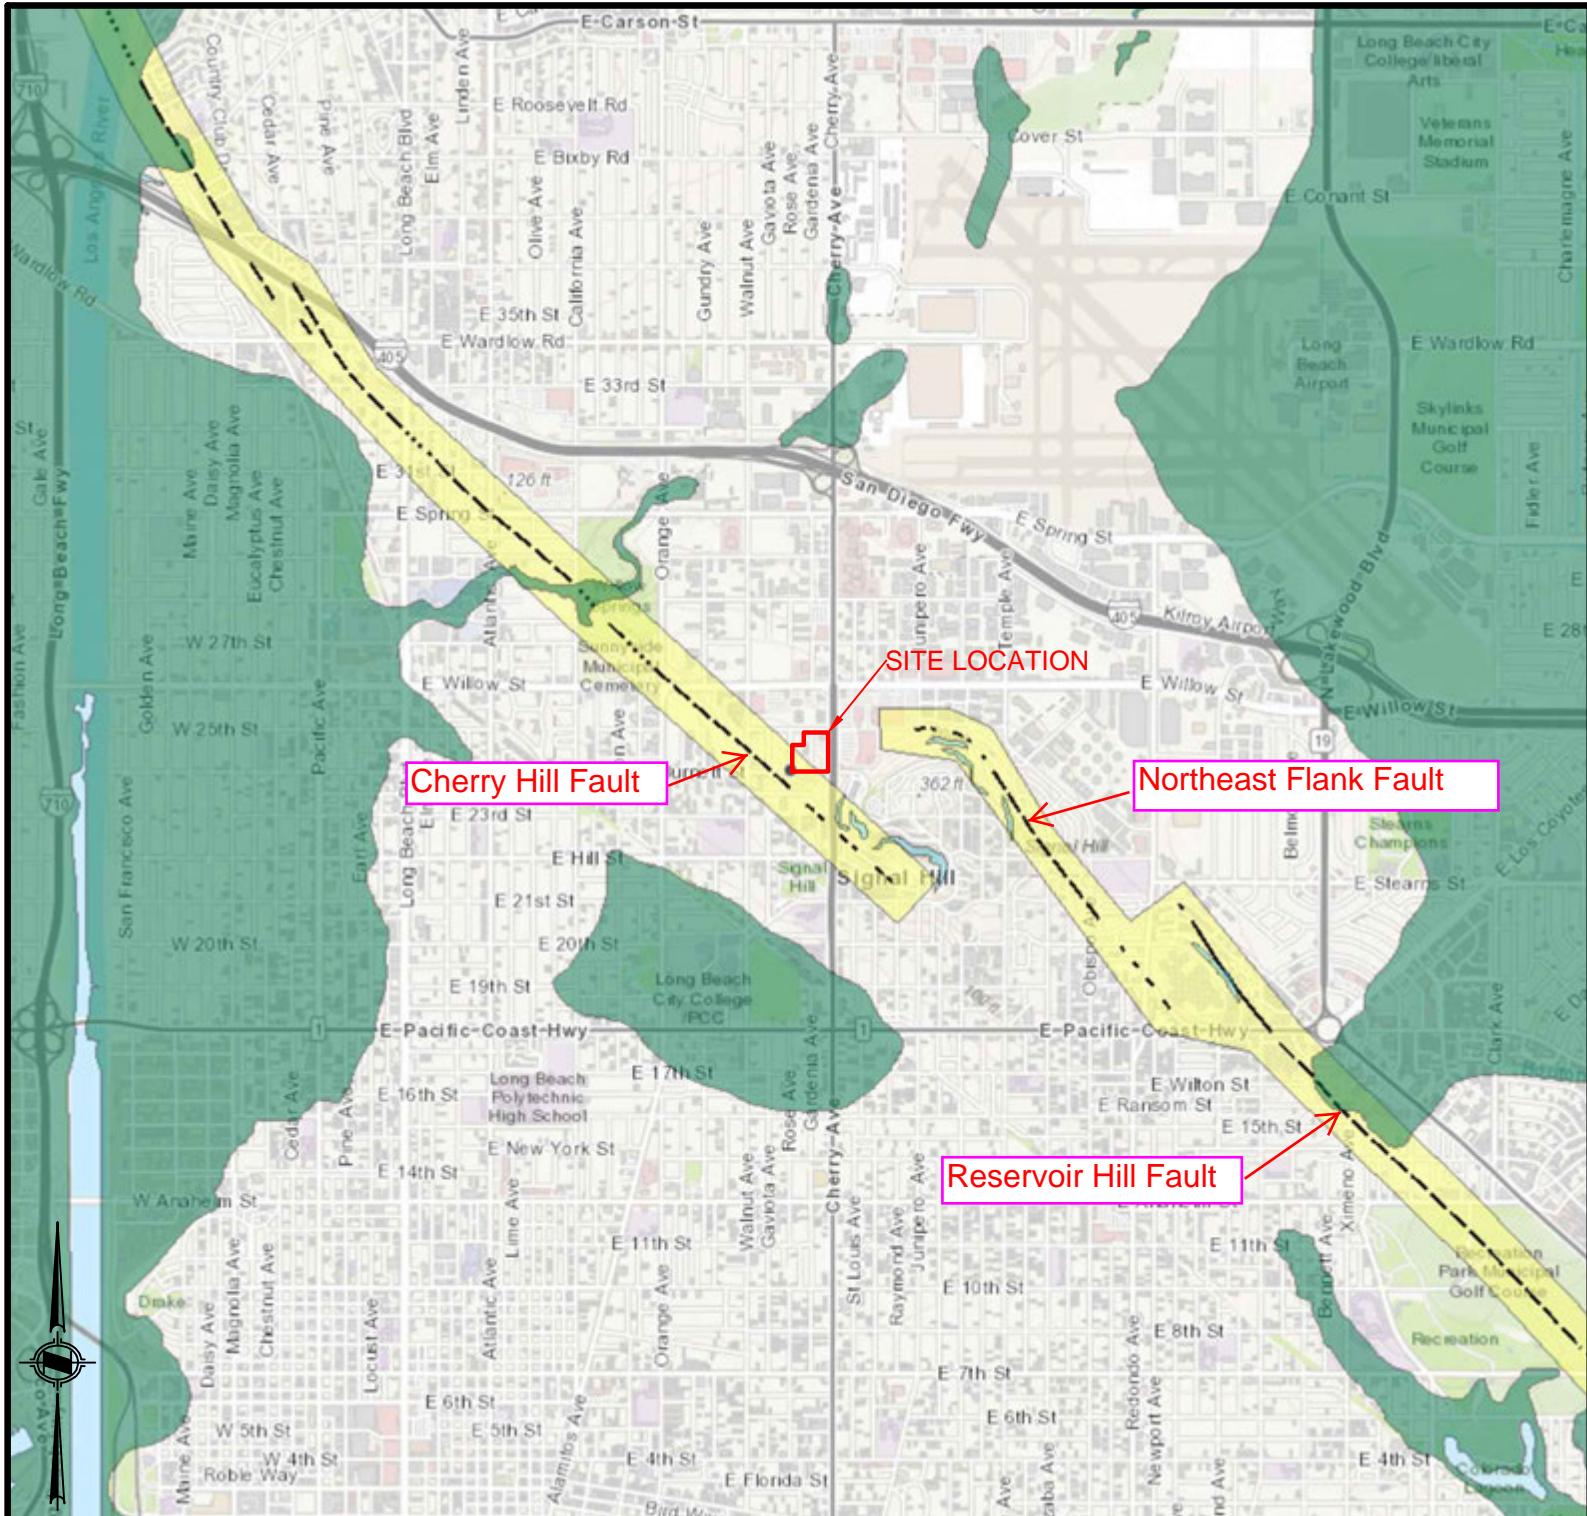
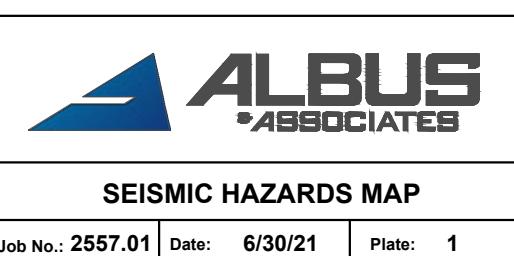
Active Fault Traces

Faults considered to have been active during Holocene time and have potential for surface rupture: Solid Line in Black or Red where accurately located; Long Dash in Black or Solid Line in Purple where approximately located; Short dash in black or solid line in orange where inferred; Dotted line in black or solid line in rose where concealed; Query (?) indicates additional uncertainty. Evidence of historic offset indicated by year of earthquake-associated event or C for displacement caused by fault creep.
